## Total Ankle Replacement in a Military Jet Pilot

- INTRODUCTION:** A total ankle replacement in a jet pilot after an open, high-energy foot and ankle fracture and dislocation with talar extrusion in a plane crash was carefully evaluated before considering fitness to fly.

Verde P, Guardigli S, Morgagni F, Roberts S, Monopoli D, Scala A. Total ankle replacement in a military jet pilot. *Aerosp Med Hum Perform.* 2020; 91(7):597–603.

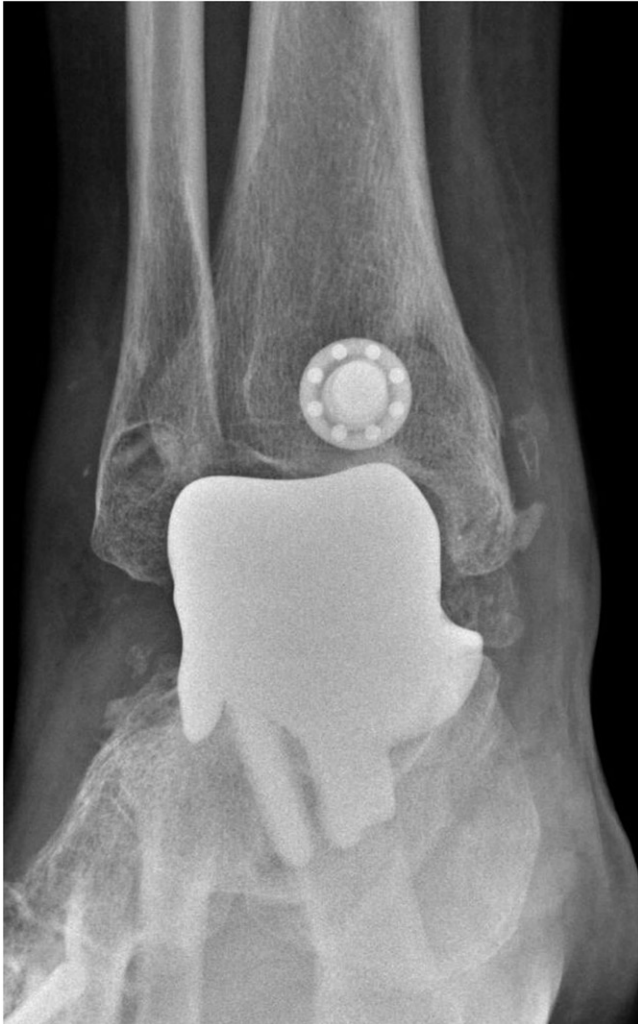
**Fig. 1.** Pre-op total ankle replacement: frontal view. The X-ray of the ankle in frontal view shows the metal talus in contact with the tibial plafond. There is no articular space. This finding explains reabsorption of the articular cartilage, the ankle ankylosis, the impossibility of walking, and the severe pain. The screw and the washer with spikes for ligament reconstruction on the distal tibia should be noted, as well as the tunnel on the fibular malleolus.

The ankle range of movement (ROM) was blocked at 30° based on 80° dorsiflexion and 110° plantar flexion. The Achilles tendon was retracted. There were no pronosupination or inversion-eversion movements since the subtalar joint was blocked by two screws at the posterior talus-calcaneal joint. At the level of the right talonavicular joint the titanium talus was directly in contact with the cartilage surface of the navicular (**Fig. 1** and **Fig. 2**).

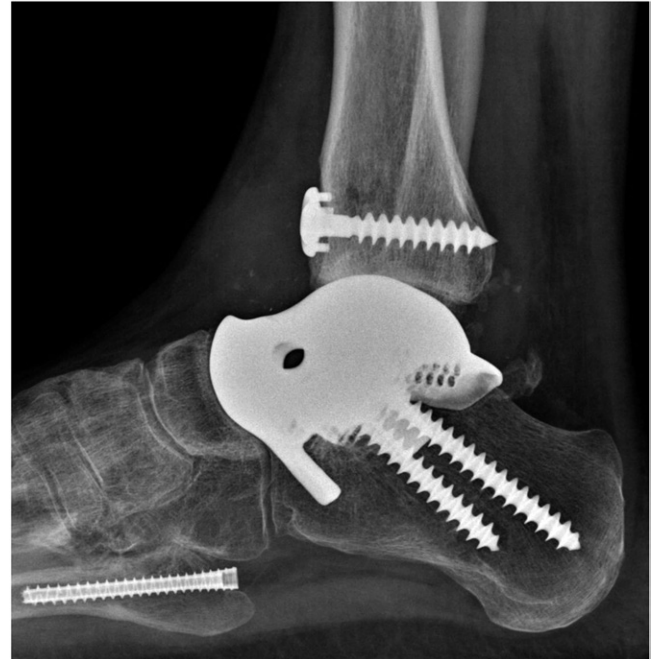
**Fig. 2.** Pre-op total ankle replacement: lateral view. The X-ray in lateral view shows the disappearance of the ankle joint space. The metallic talus is in contact with the tibial plafond. The reabsorption of articular cartilage is apparent.

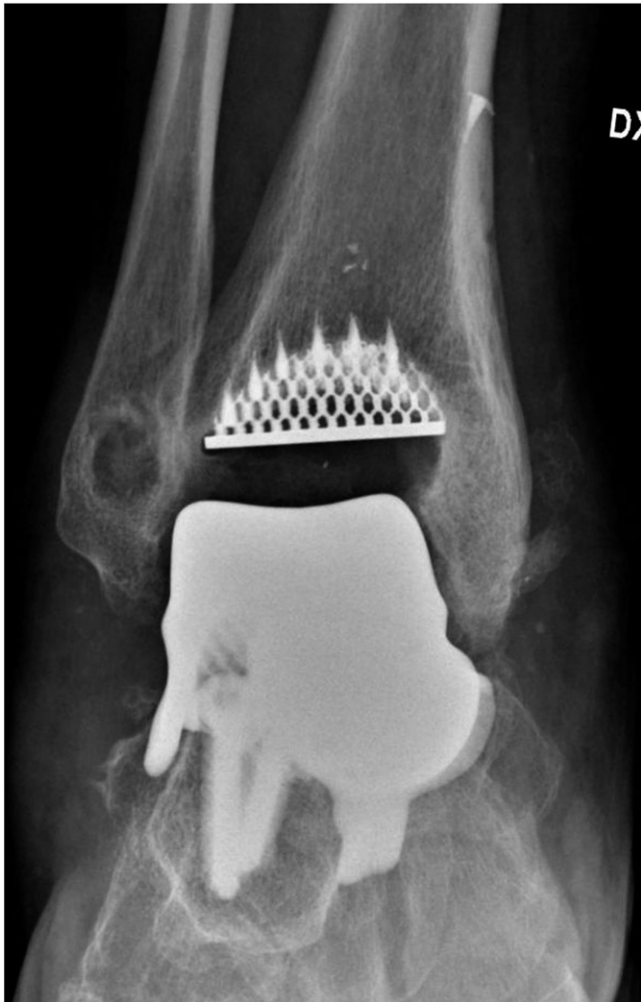
**Fig. 3.** Post-op total ankle replacement: frontal view. The postoperative frontal view radiograph of the ankle joint replacement shows the volume of the tibial implant and the alveolar shape. It was designed to fill the hole left in the distal tibia by the removal of the screw and ligament washer for ligament reconstruction. The polyethylene inlay has restored the joint space. The range of motion of the ankle is quite normal and the pain is absent or tolerable.

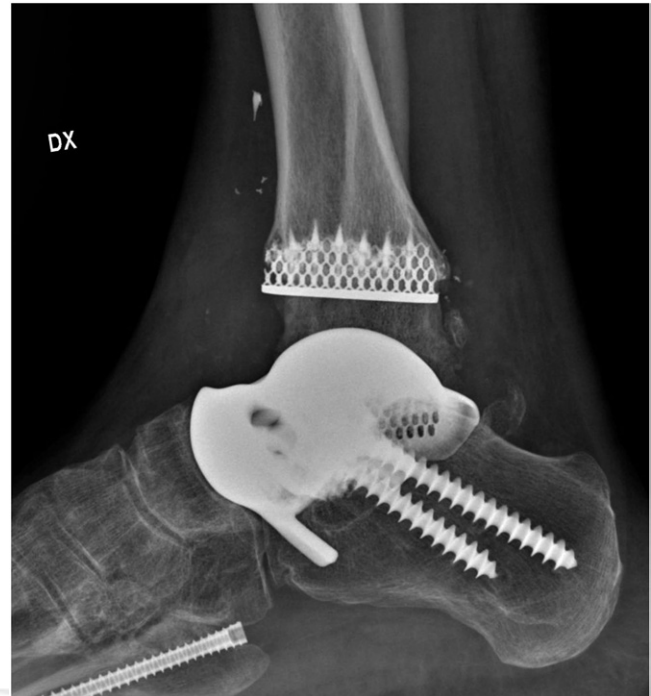
**Fig. 4.** Post-op total ankle replacement: lateral view. The postoperative lateral view radiograph of the ankle joint replacement shows the tibial component with its alveolar structure. The polyethylene inlay has restored the joint space.
